EAGLE LAKE SEWER UTILITY DISTRICT

Lift Station Improvements

January 10, 2022
William Hein, P.E.

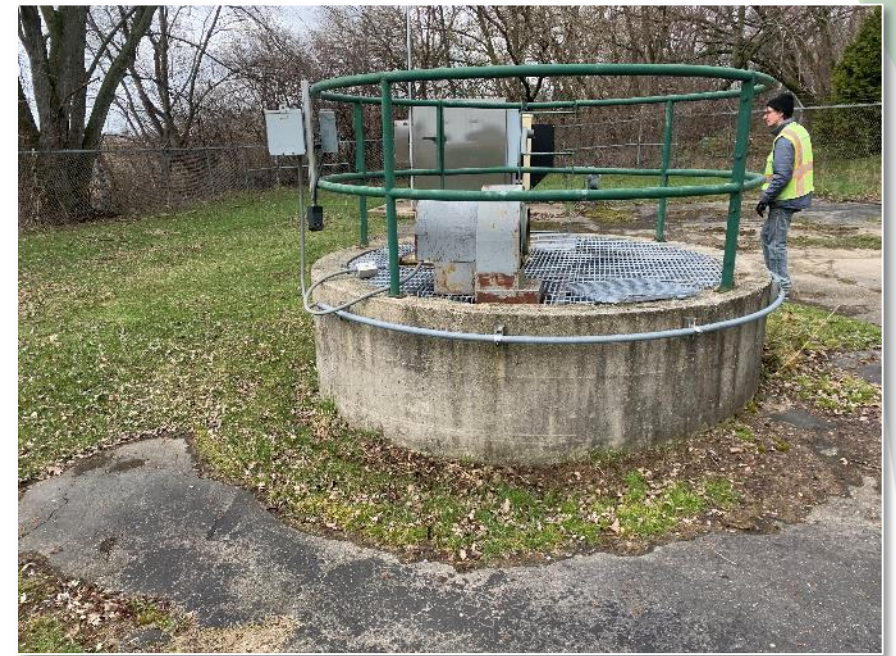
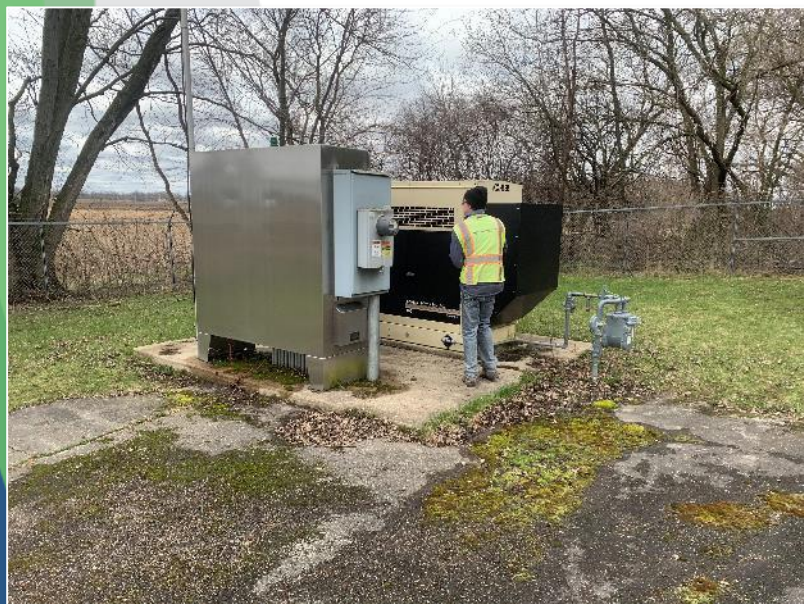
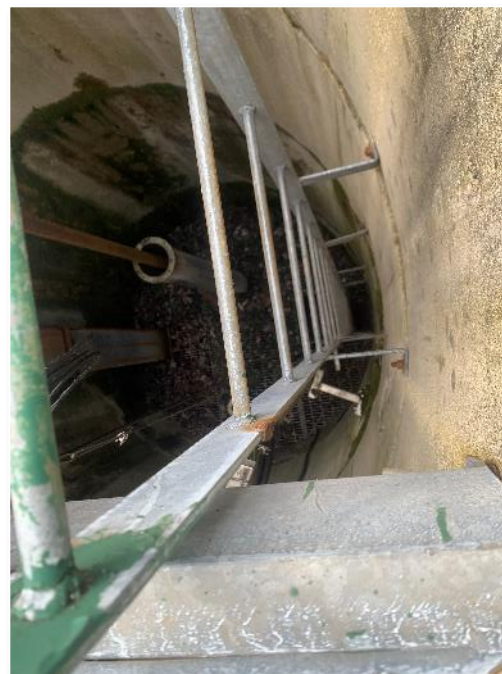
Lift Station 1

- Extensive corrosion, including the dry well.
- Pumps lack sufficient capacity.
- Confined entry permit.
- Force main is experiencing failures.

- Abandon drywell.
- Install a new 10' dia well and larger submersible pumps.
- Replace controls, WWTP flow meter, and standby generator.
- Install driveway and replace force main.

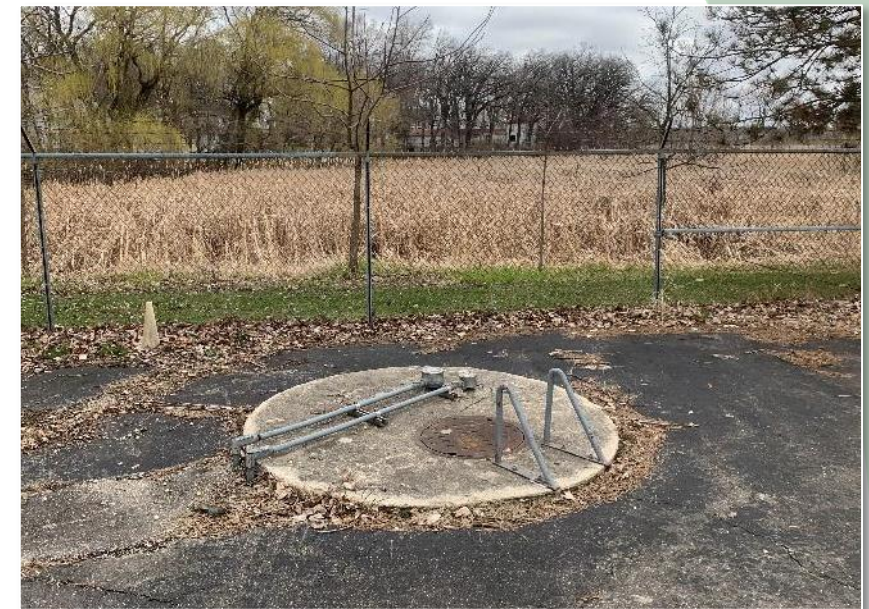
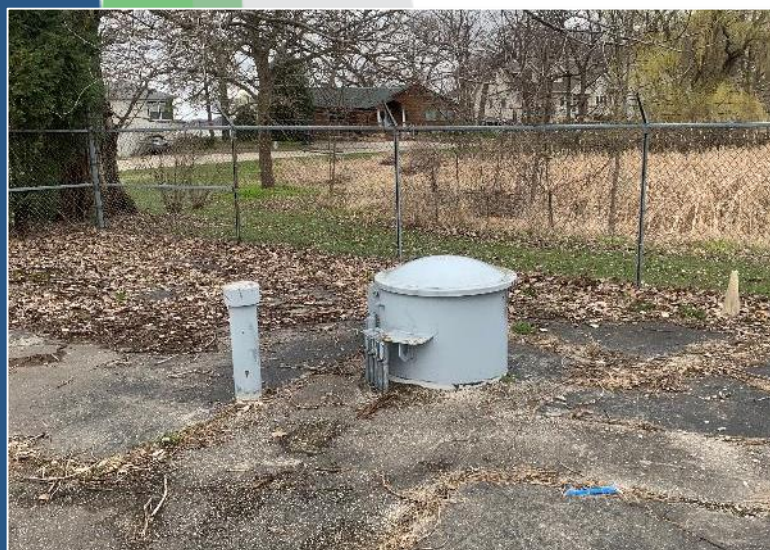
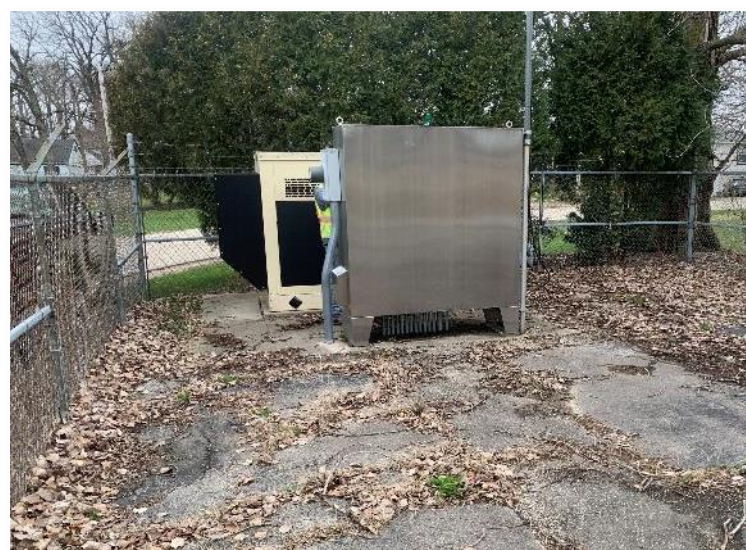
Lift Station 2

- Wet well is in fair condition, as are the dry well piping, valves, and hardware.
- Standby power, controls, SCADA, and force main have reached the ends of their design lives.
- Pumps lack sufficient capacity.
- Difficult to access pumps.

- Abandon drywell.
- Install new higher capacity submersible pumps in new wetwell.
- Replace station controls and standby generator.
- Add a flow meter.
- Install driveway and replace force main.

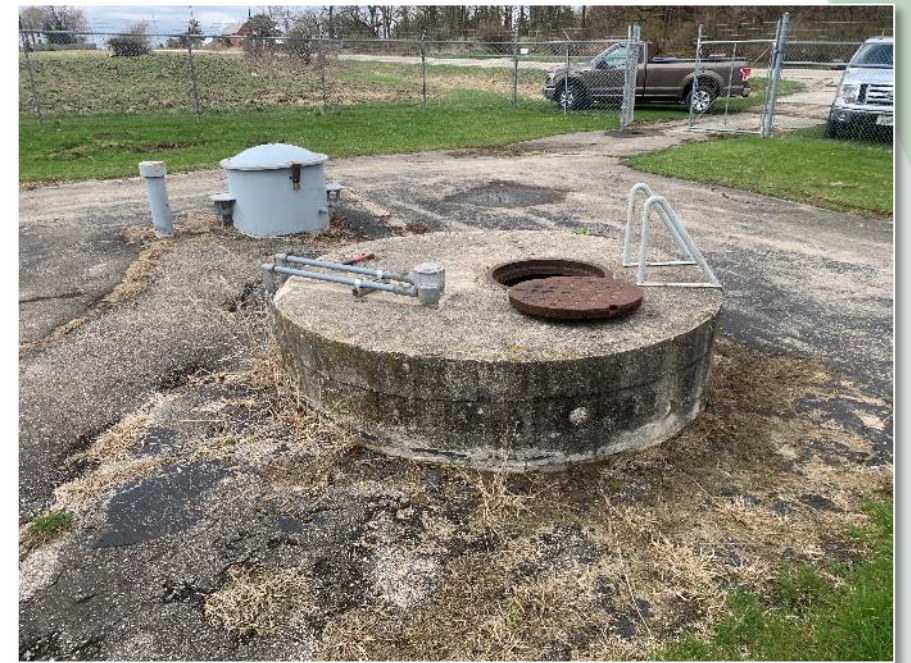
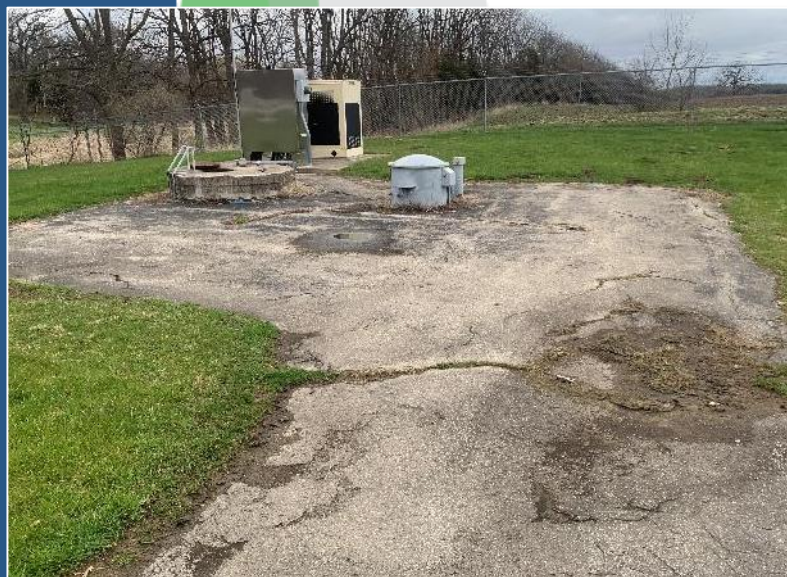
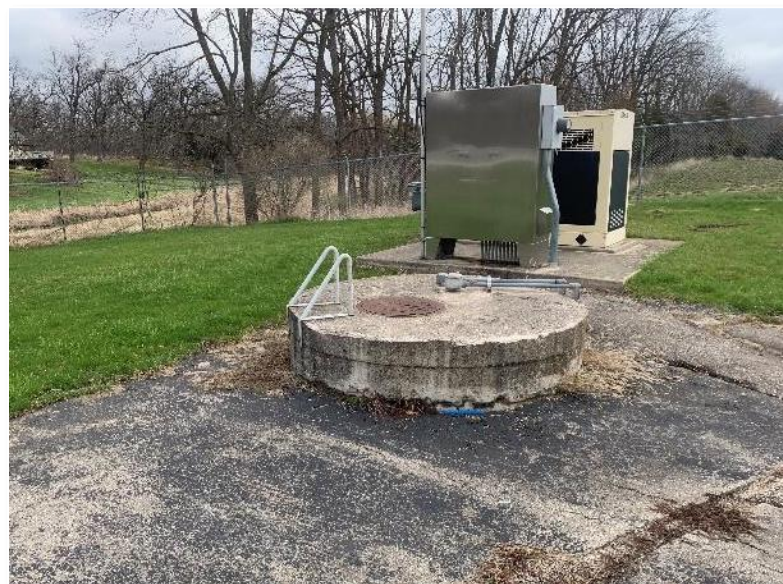
Lift Station 3

- No significant wet well corrosion.
- Extensive corrosion in the dry well.
- Pumps are in poor condition and lack sufficient capacity.
- Difficult to access pumps.
- Access pavement is deteriorating.

- Abandon drywell.
- Install larger submersible pumps in existing wet well.
- Replace station controls and standby generator.
- Add flow meter.
- Repave driveway.

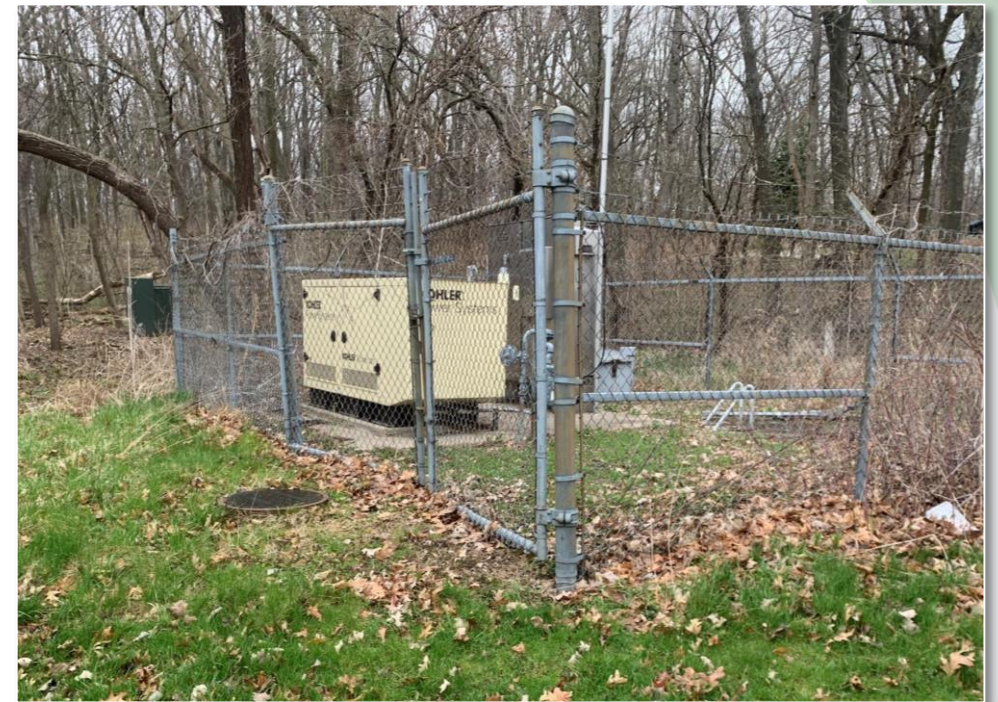
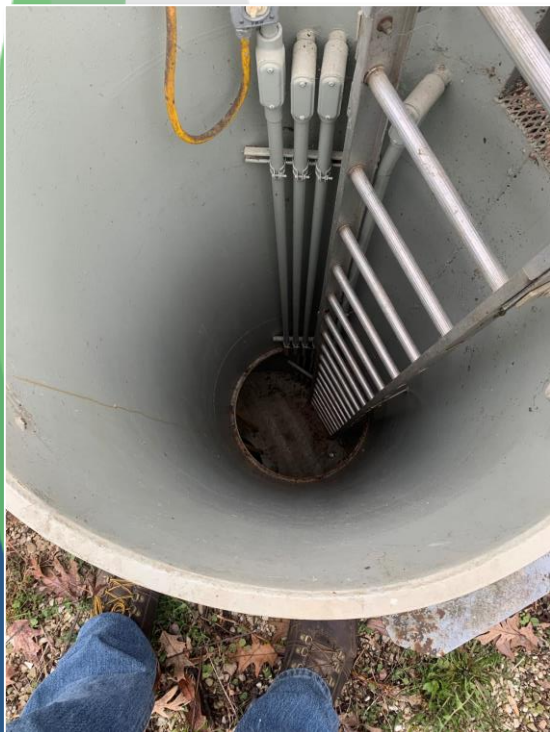
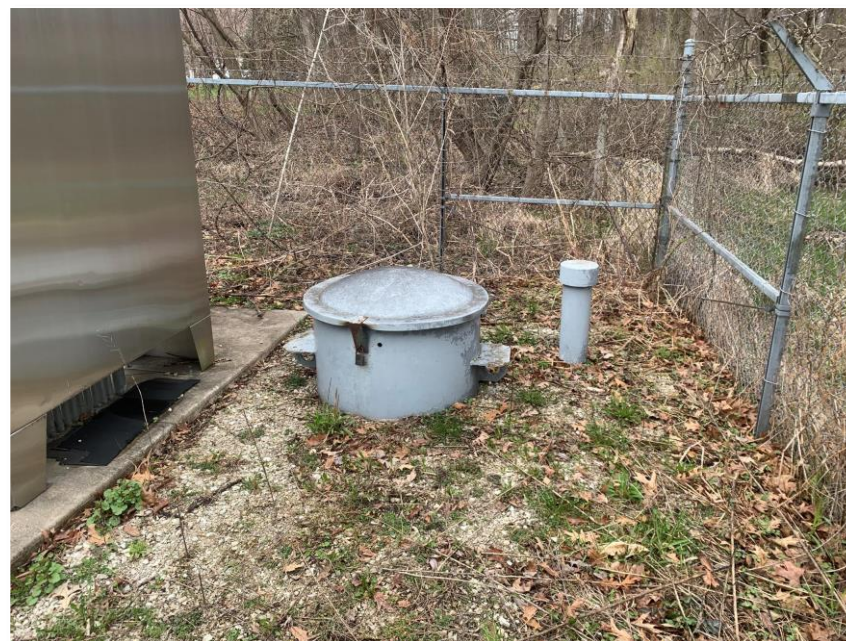
Lift Station 4

- Wet well appears to be in fair condition.
- Dry well, valves, and piping are corroded.
- Pumps lack sufficient capacity.
- Difficult to access pumps.

- Abandon drywell
- Install larger submersible pumps in existing wet well.
- Replace station controls.
- Add flow meter
- Install driveway.
