EAGLE LAKE SEWER UTILITY DISTRICT

Lift Station Improvements

January 10, 2022
William Hein, P.E.

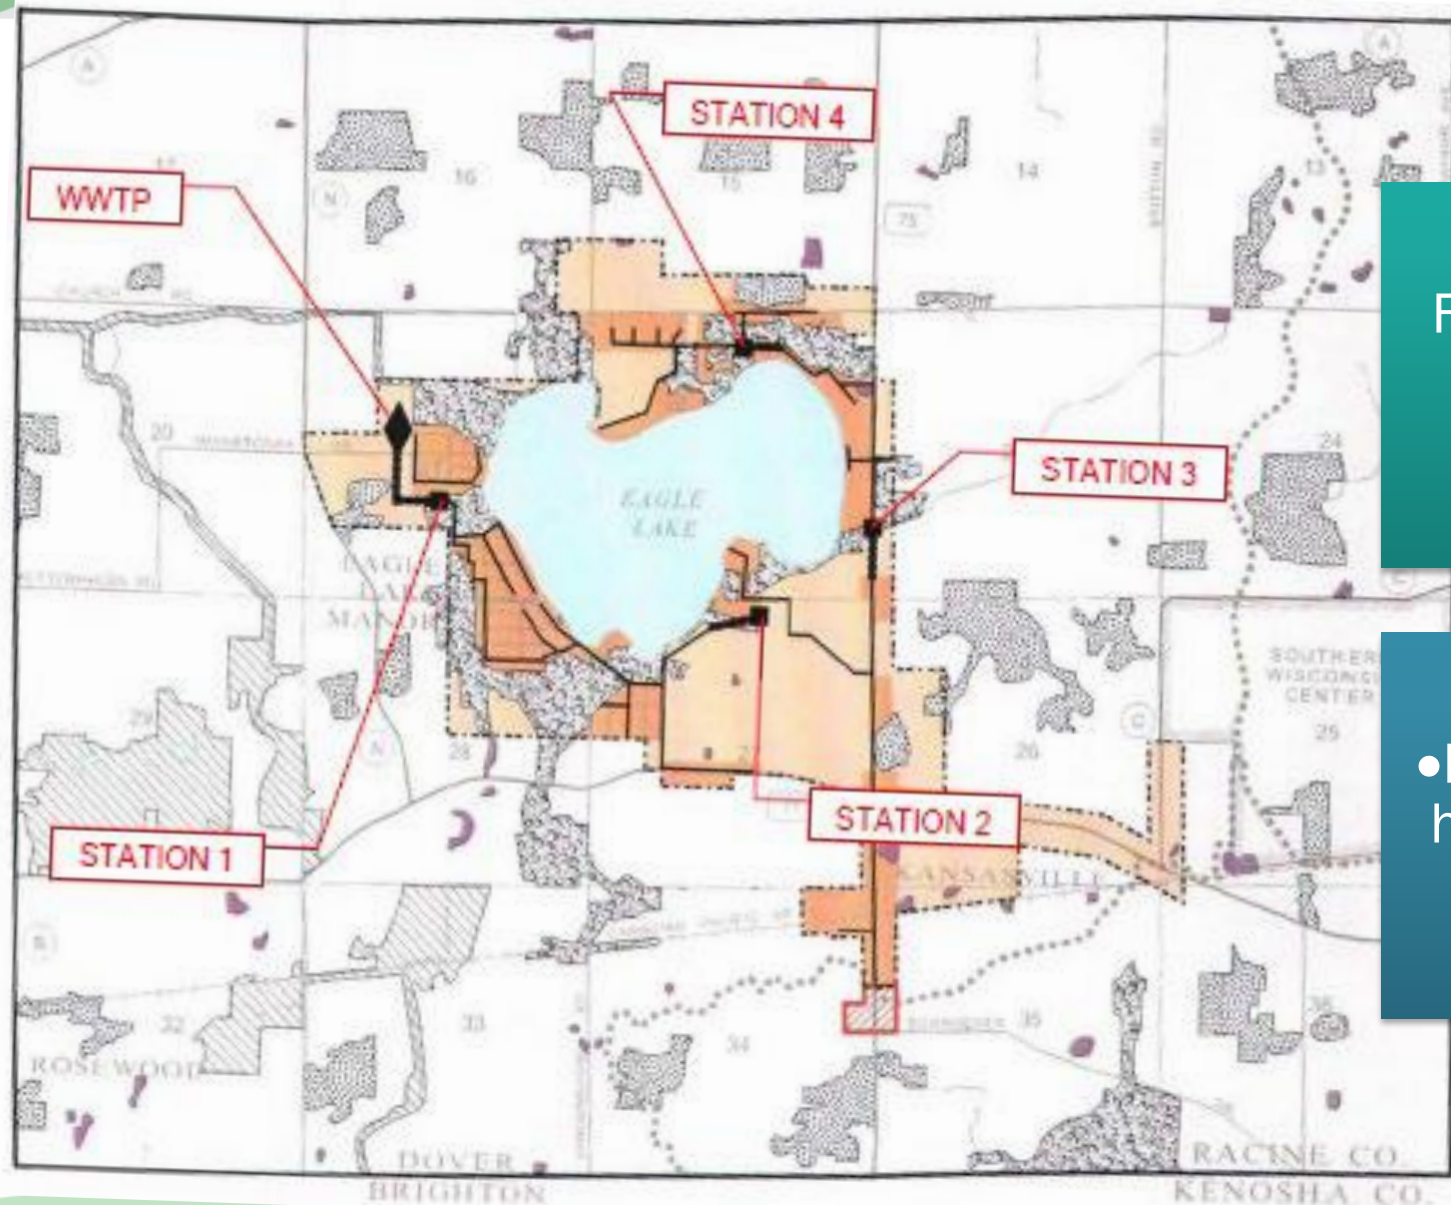
Facilities are 44 years old and beyond their service lives.

- Insufficient firm pumping capacity for peak flows.

- Force main breakages have increased due to corrosion.

- Lift stations are permit required confined spaces, making maintenance difficult and hazardous.
